GROUND ANCHOR LOADS MEASURED IN A SEISMIC EVENT IN SOUTH ACCESS MALLECO VIADUCT ANCHORED WALL

Here we present the load measurements of an instrumented Anchored Wall which was built in 2002 in the south access of the Malleco Viaduct, Route 5 Temuco-Collipulli, IX Region of Chile.

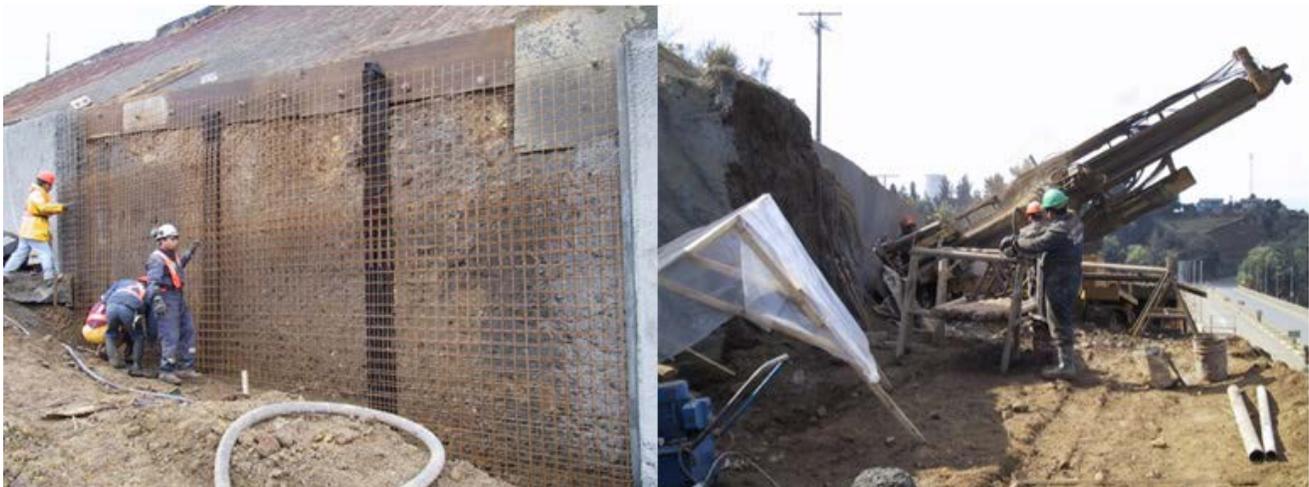
Fig. 3 – Excavation, draining strips, mesh and shotcrete. Execution of ground anchors.

The construction of the wall was made by shotcrete and in panels, moving progressively in a sequence such that the upper cloths had their stability ensured by the lower support on the ground still unexcavated or already concreted panels. The normal construction sequence consisted of drilling anchors, then install the reinforcement, shotcrete and then finally, tensioning and testing of ground anchors with the corresponding termination (injection) of the head.

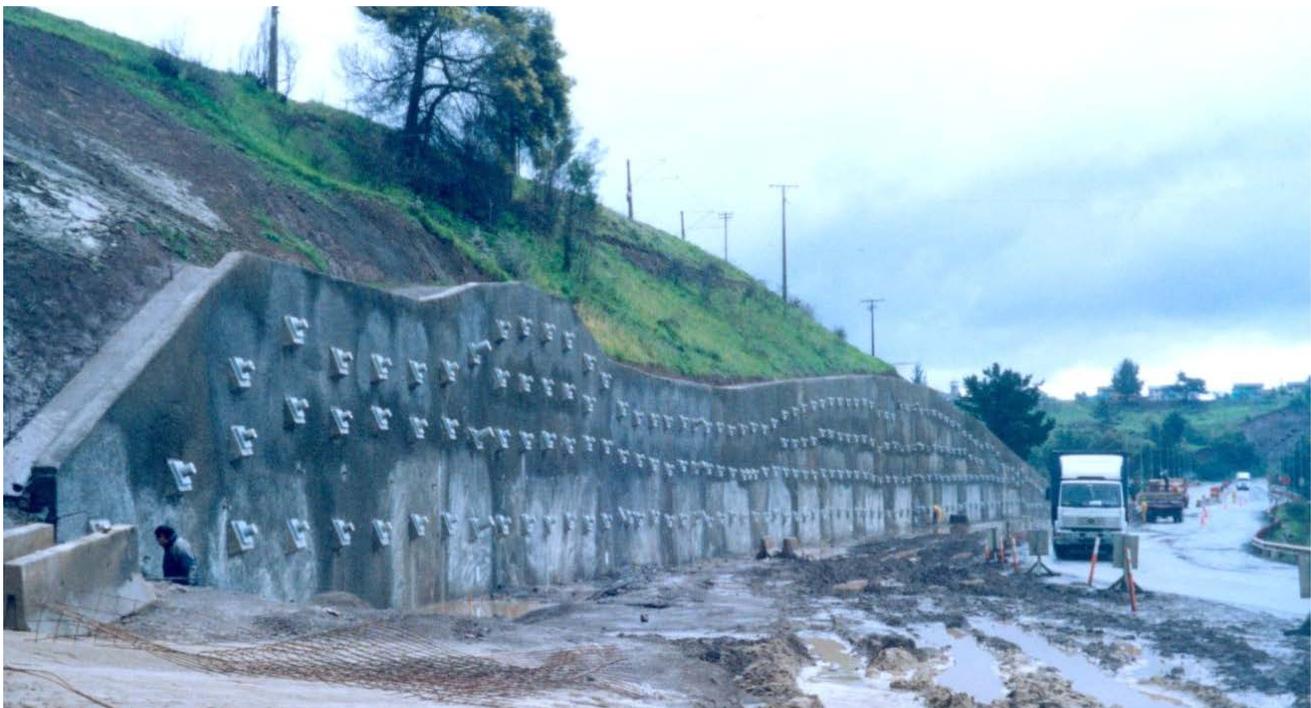
Fig. 5 – Anchored Wall building just finished.
